INDOOR AIR QUALITY ASSESSMENT

**Ralph B. O'Maley Middle School
32 Cherry Street
Gloucester, Massachusetts**

Prepared by:
Massachusetts Department of Public Health
Bureau of Environmental Health Assessment
July, 2002

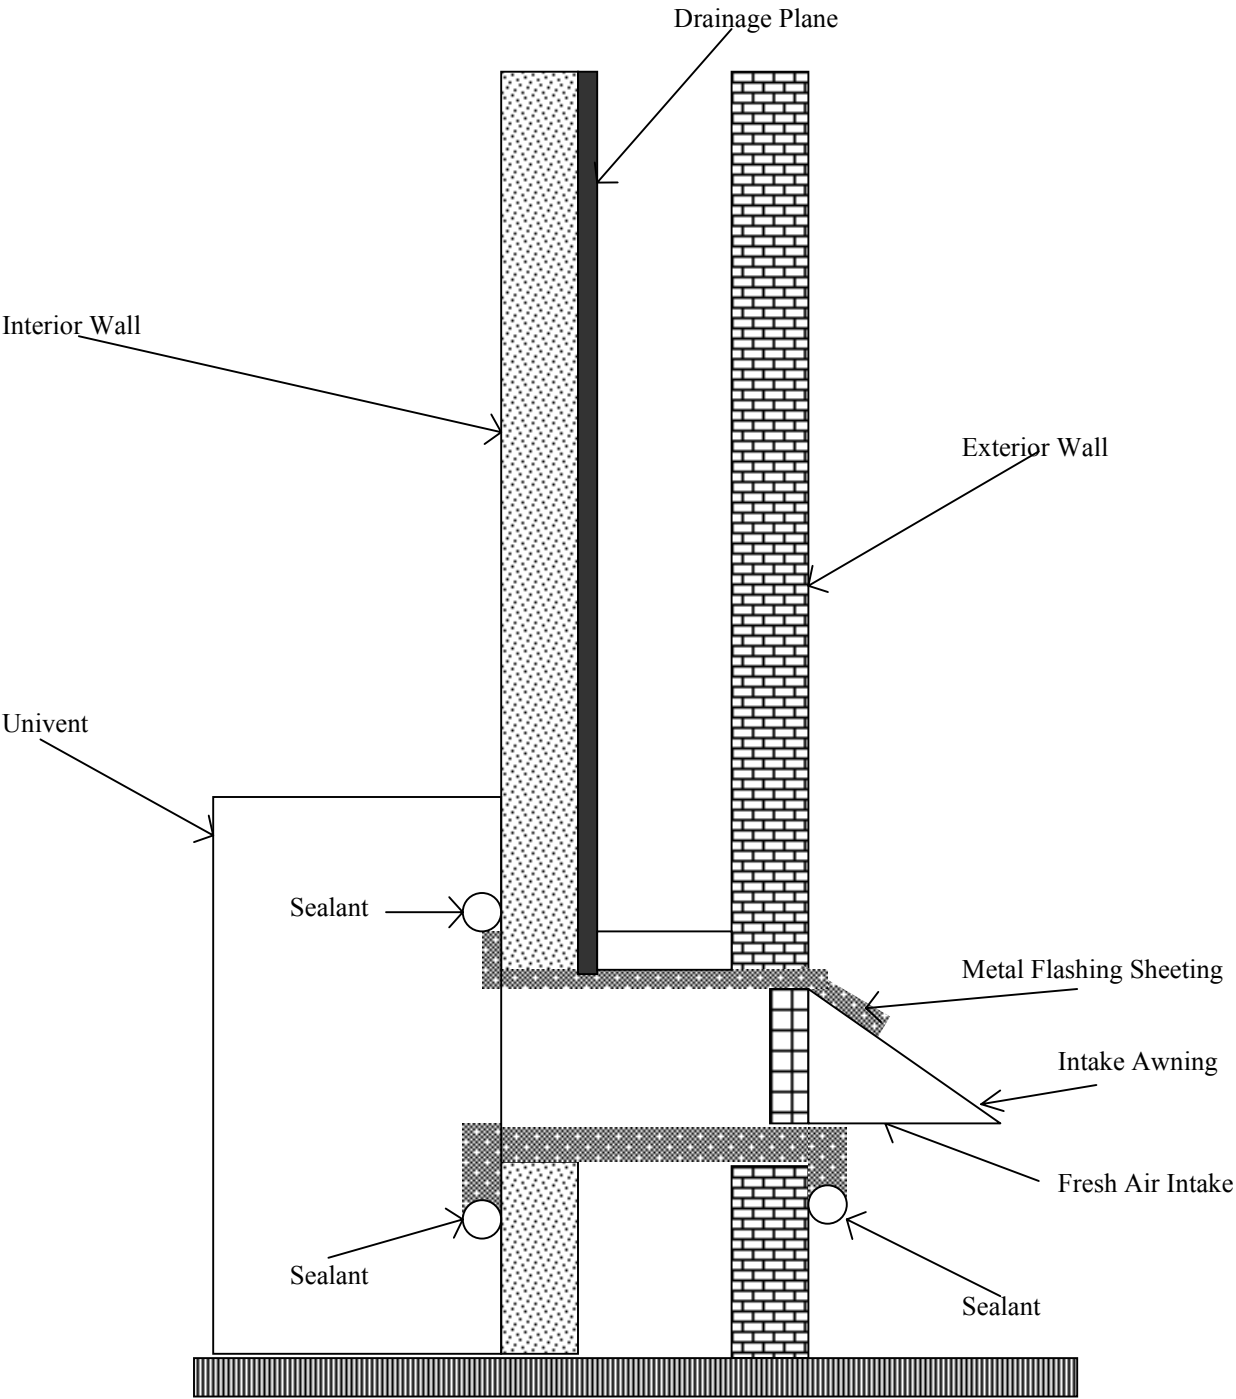
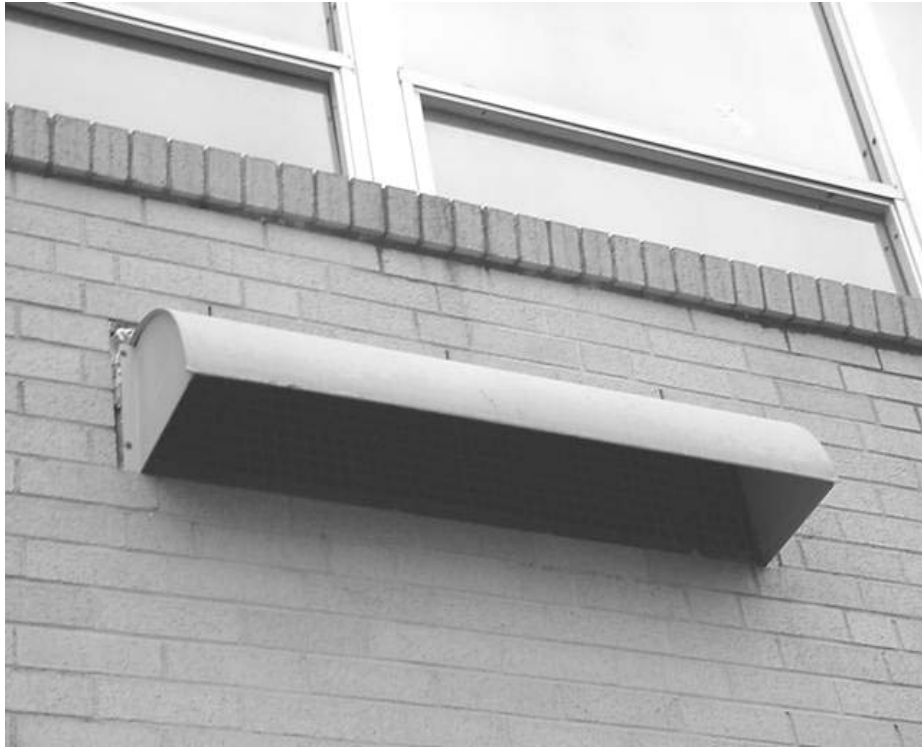
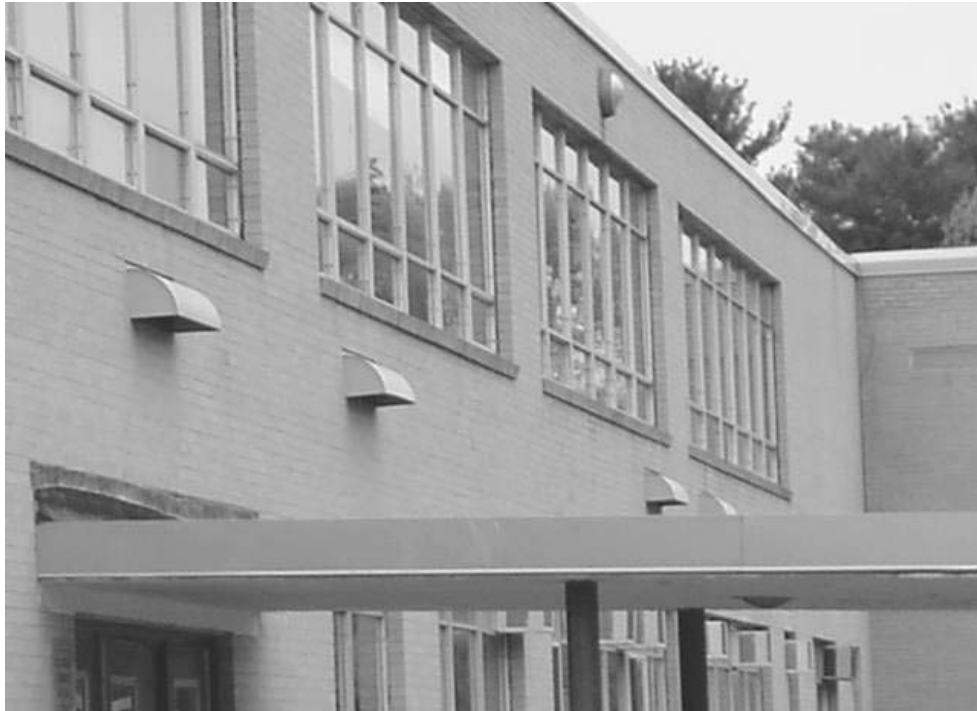
Figure 2
Protection of Univent Fresh Air Intake Vent Using A Metal Awning Shield from Driving Rain

Fresh Air Intake Awning/Shield Recommended For Installation Over Fresh Air Intakes
(Picture Taken at King Phillip Regional High School, Wrentham, MA)

1. Examine the seal around each univent fresh air intake louver grille for sealant integrity. Reseal each joint to prevent air bypass.
2. Seal all pipe holes within univents.
3. To prevent water penetration in/around univents consider installing an awning type structure to prevent penetration from wind driven rain. Pictures 19 and 20 depict a style of fresh air intake used to shield the fresh air intakes at the King Phillip Regional High School in Wrentham, MA. The shield should have flashing installed to direct rainwater from the exterior wall system (see Figure 2).
4. Replace/repair missing/damaged radiator baseboard diffusers throughout the school.

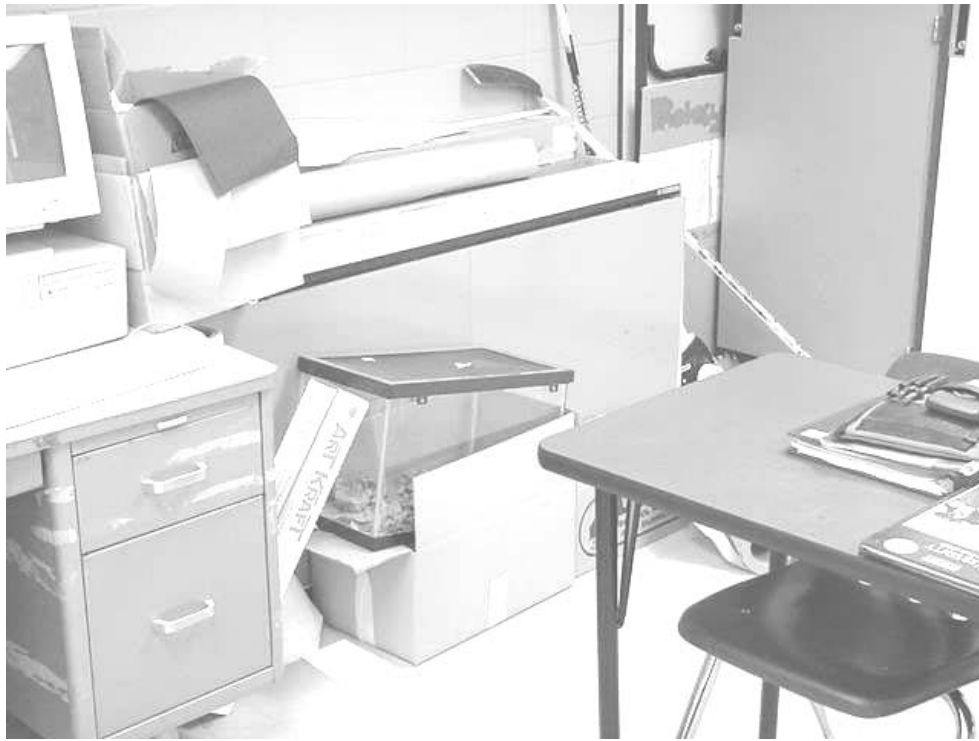
Picture 1

Fresh air in exterior classrooms is supplied by a unit ventilator (univent) system. Univents draw air from outdoors through a fresh air intake located on the exterior walls of the building and return air through an air intake located at the base of each unit ([see Figure 1](#)). Fresh and return air are mixed, filtered, heated and provided to classrooms through a fresh air diffuser located in the top of the unit. Univents have three controls: low, high and off. Univents were found turned off in classrooms throughout the school; some due to birds nesting in close proximity to outside air intakes (see **Microbial/Moisture Concerns** section of this report). Obstructions to airflow, such as papers and books stored on univents and bookcases, carts and desks in front of univent returns were seen in a number of classrooms (see Picture 1). In order

Classroom Univent Obstructed By Various Items

7. Inspect exhaust motors and belts for proper function, repair and replace as necessary.
8. Remove all blockages from univents and exhaust vents.
9. Consider having the systems re-balanced every five years by an HVAC engineering firm.

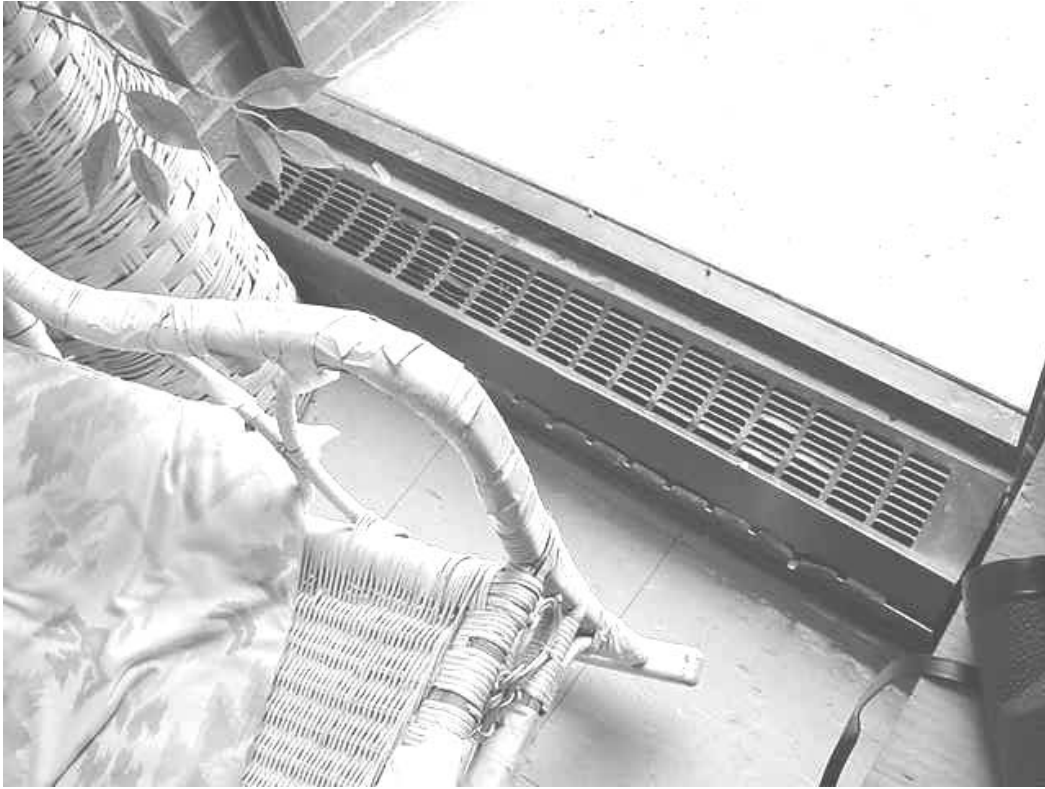
Picture 2

Baseboard Radiator in Classroom

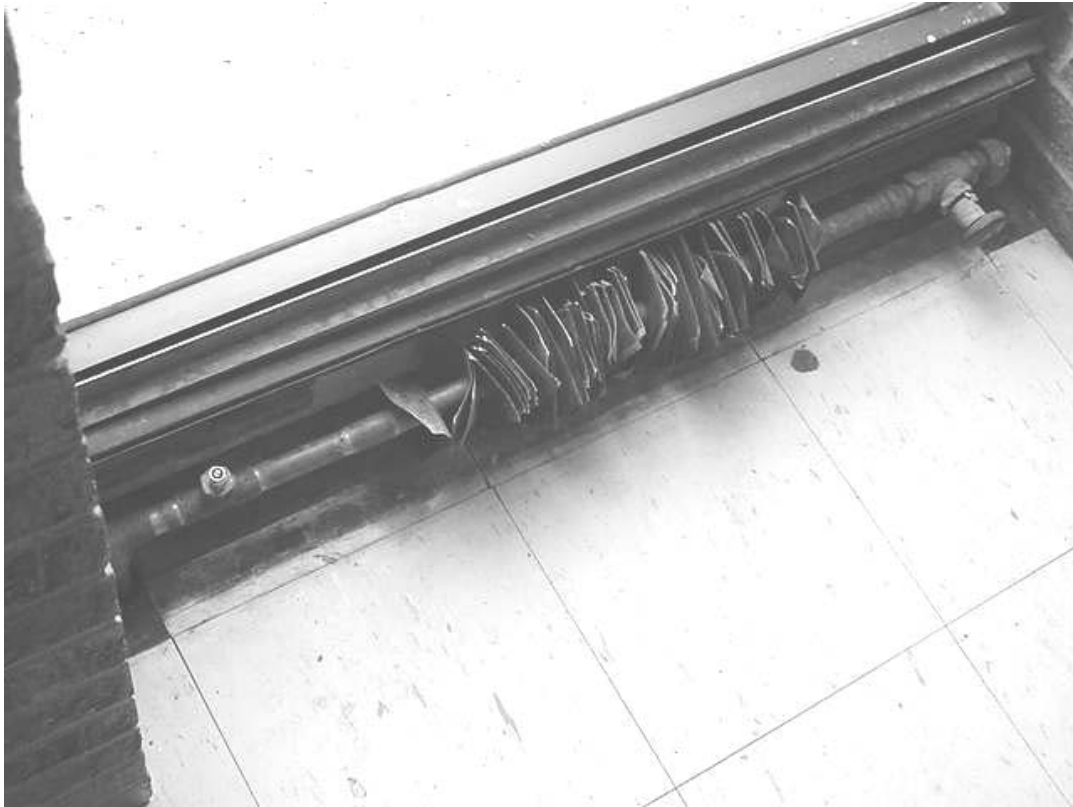
Picture 3

Temperature readings ranged from 69° F to 75° F, which were very close to the BEHA comfort guidelines. The BEHA recommends that indoor air temperatures be maintained in a range of 70° F to 78° F in order to provide for the comfort of building occupants. A number of temperature control/comfort complaints were expressed throughout the building. Baseboard radiators supplement the mechanical ventilation system in providing heat (see Picture 2). This equipment was found missing or broken and damaged in many areas throughout the building (see Picture 3).

Damaged Classroom Baseboard Radiator (This Was Observed in a Large Number of Areas)

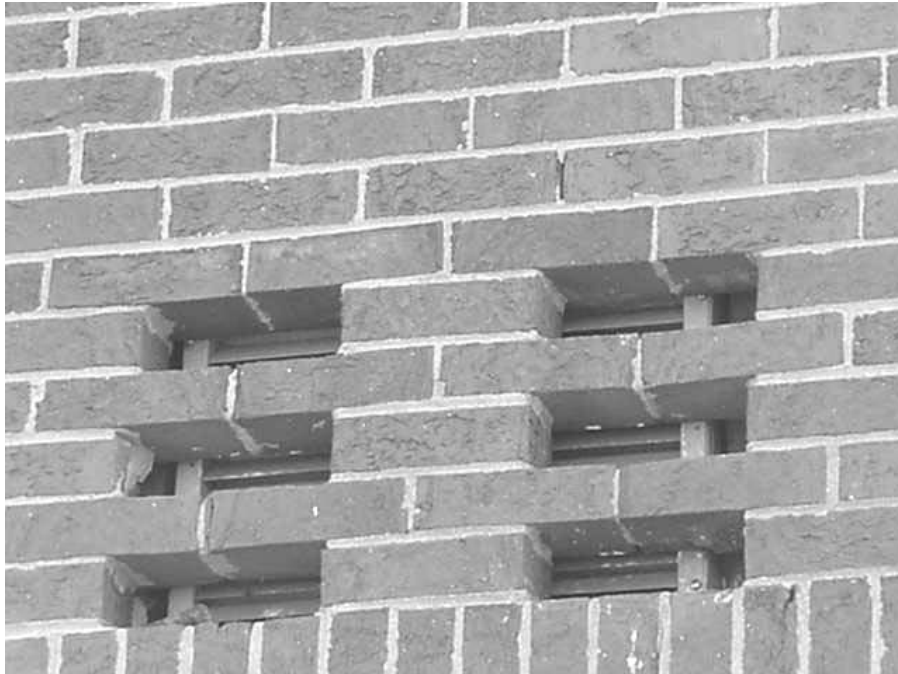
Picture 4

Fresh Air Intake Installed Inside the Exterior Wall

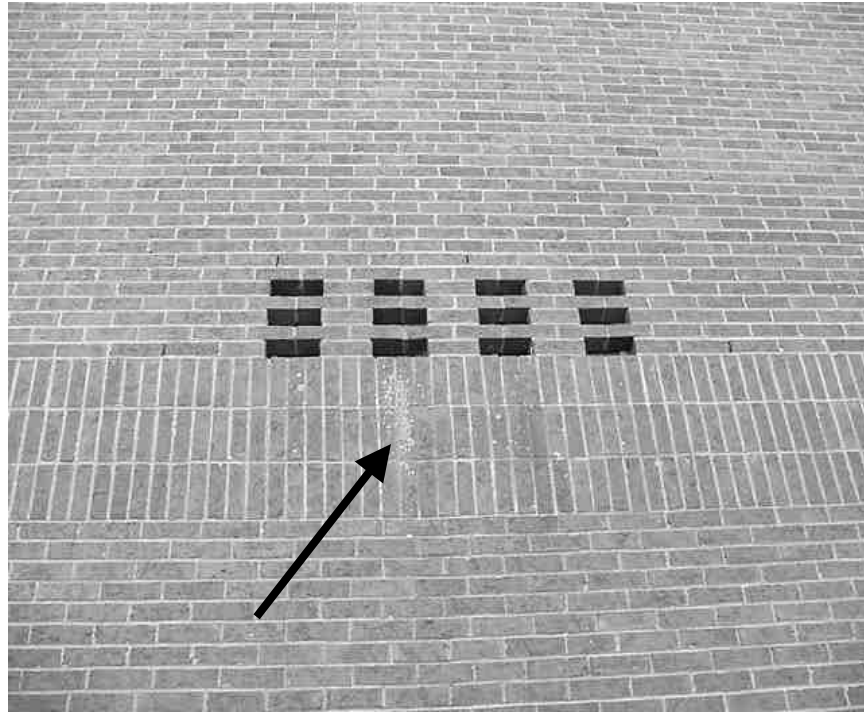
Picture 5

Water Damage and Lichen Growth below Fresh Air Intake, Indicating Unusual Water Exposure to Brick

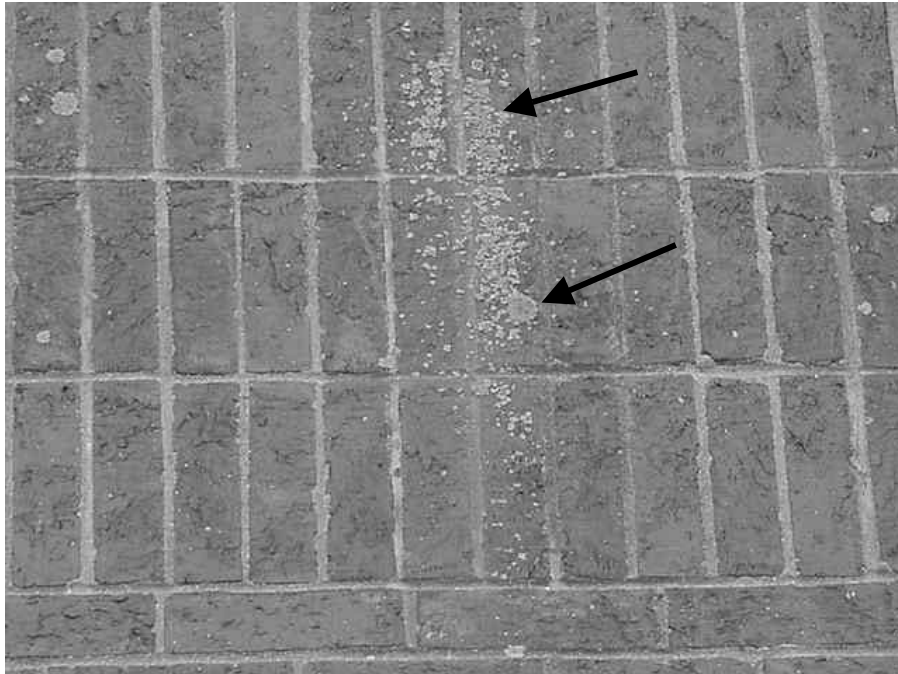
Picture 6

Close Up Of Water Damaged Brick, Note Lichen

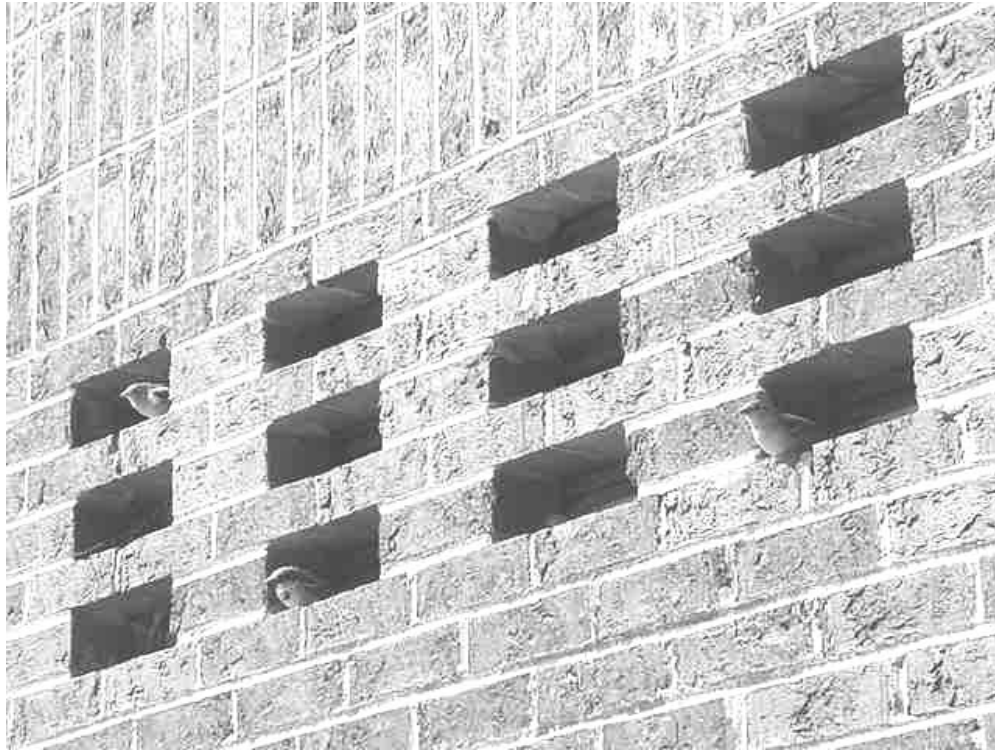
Picture 7

The univent fresh air intake configuration also makes these vents ideal bird roosting areas. Birds and nesting materials were observed in the brick recesses in many of these univent air intakes (see Picture 7), which can allow for associated bird wastes/odors to enter classrooms via the air intake vents. Also of note is the condition of the compound used to seal the sides of univent fresh air intakes to the interior wall system. Breaches (see Picture 8) or entirely unsealed seams were noted in univents around the entire school complex. These breaches can allow for birds to penetrate into the interior of the wall system. Each univent is built into a wall mounted cabinet system. This configuration draws air from the interior of the cabinet system. Pipes connected to the univent heating coil pass into the floor through large, open holes. If these floor

holes open to the sides of the fresh air louver system, the operation of the univents can draw air through the breaches and over bird roosting materials. Birds can be a source of disease. Bird wastes and feathers can contain molds, which can also be irritating to the respiratory system. Bird wastes in a building raise concerns over diseases that may be caused by exposure to bird wastes. These conditions warrant clean up of bird waste and appropriate disinfection.

Birds Nesting In Brickwork/Univent Air Intakes

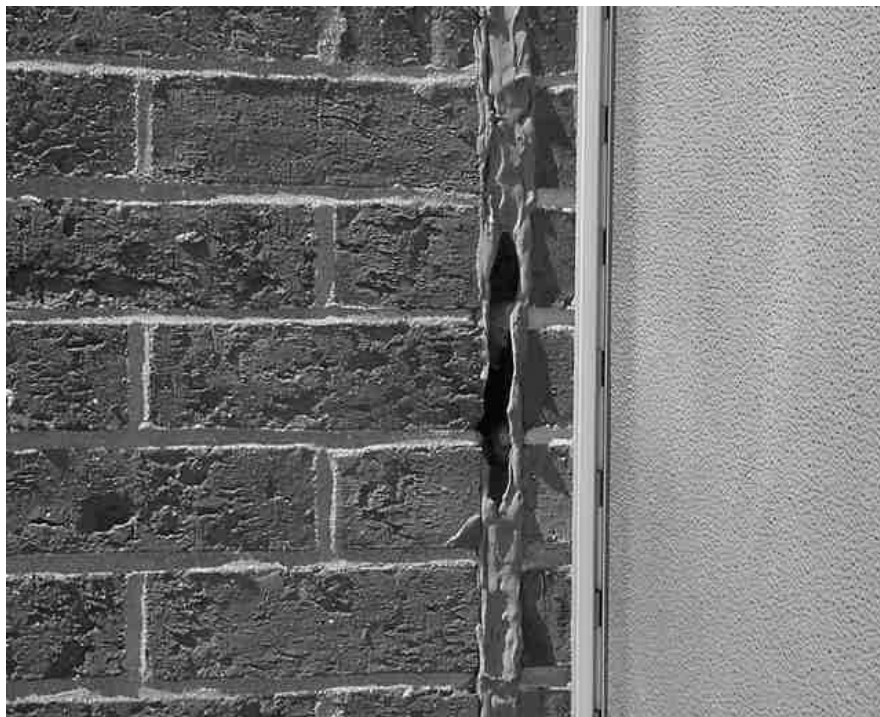
Picture 9

Gymnasium Expansion Joint

4. Examine all expansion joint seals on the exterior wall system. Reseal all expansion joints with damaged, missing or eroded sealant.
5. To maximize air exchange, the BEHA recommends that both supply and exhaust ventilation operate continuously during periods of school occupancy independent of classroom thermostat control.

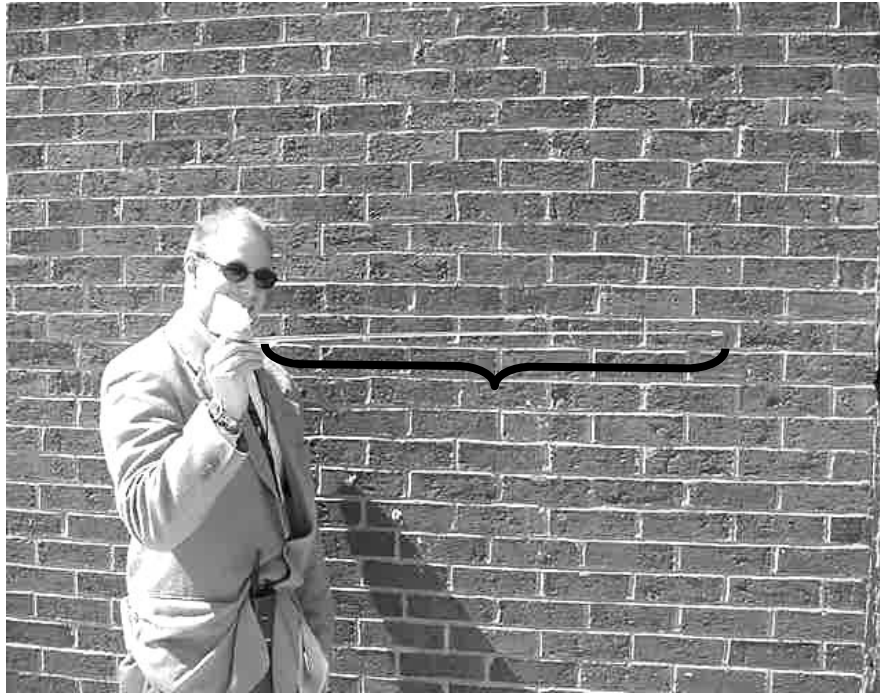
Picture 10

Length of Probe Inserted Into Expansion Joint Sealant

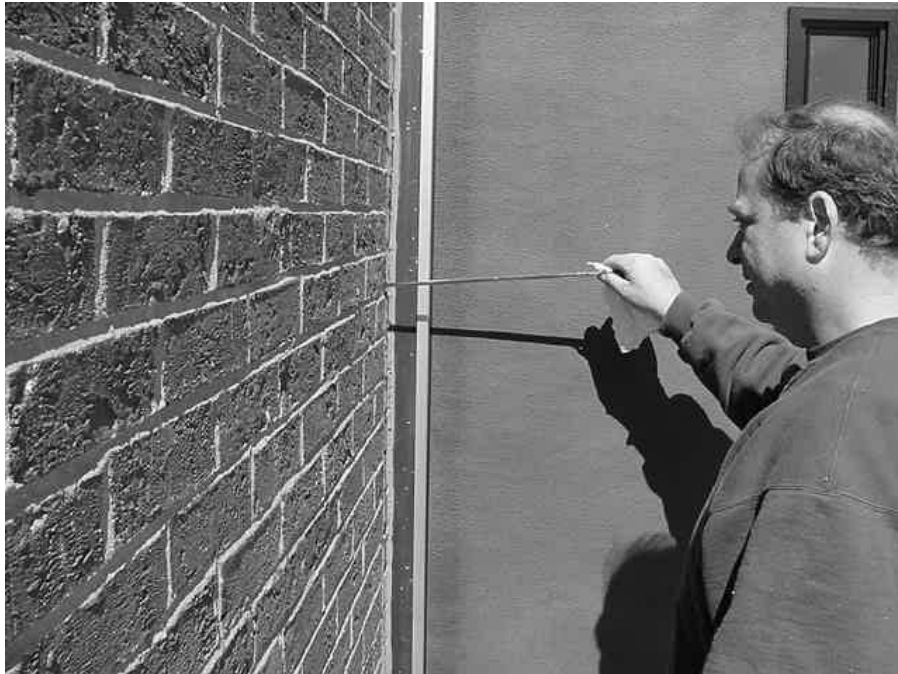
Picture 11

Space In Gymnasium Wall Joint, Note Length of Probe

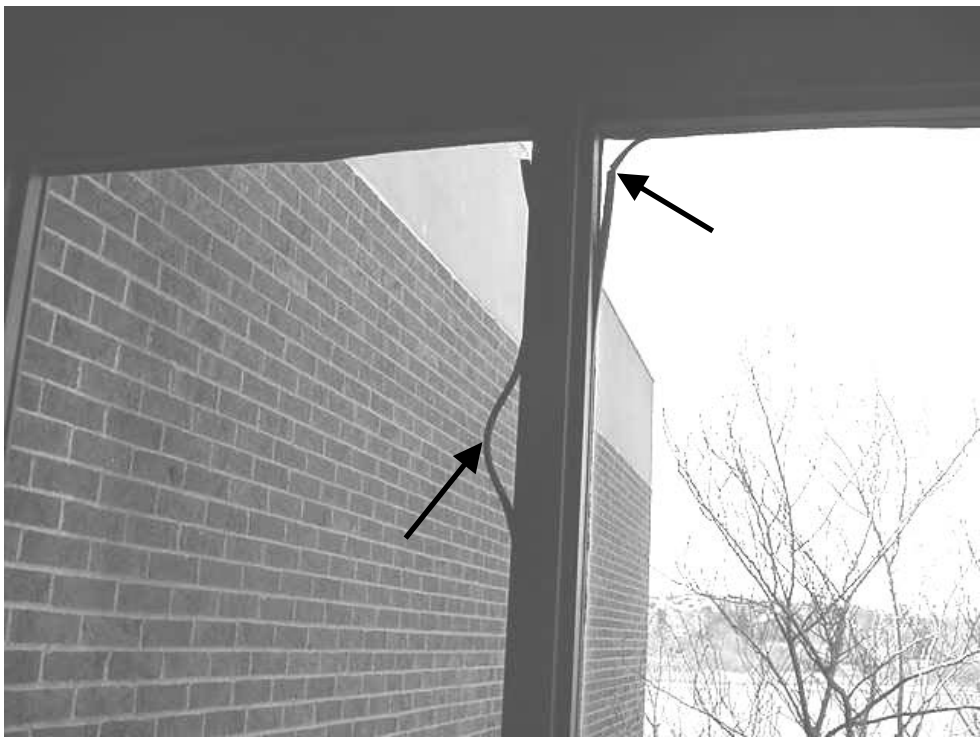
Picture 12

A number of classrooms have water-damaged ceiling tiles which can indicate leaks from either the roof or plumbing system. Water-damaged ceiling tiles can provide a source of mold and should be replaced after a water leak is discovered and repaired. Caulking around windows was crumbling/damaged throughout the building indicating that the water seal is no longer intact (see Picture 12). The library had a skylight with a broken window. Broken windows and damaged window caulking can lead to water penetration and subsequently, mold growth under certain conditions. Replacement of caulking and repairs of window leaks are necessary to

prevent water penetration. Repeated water damage can result in mold colonization of window frames, curtains and items stored on windowsills. School officials reported that the Gloucester School Department has allocated funds for the replacement/repair of windows.

Failing Window Caulking

13. Continue with plans to repair/replace window systems.
14. Clean and maintain aquariums and terrariums to prevent bacterial/mold growth. Remove decaying fish from aquarium in classroom 111.

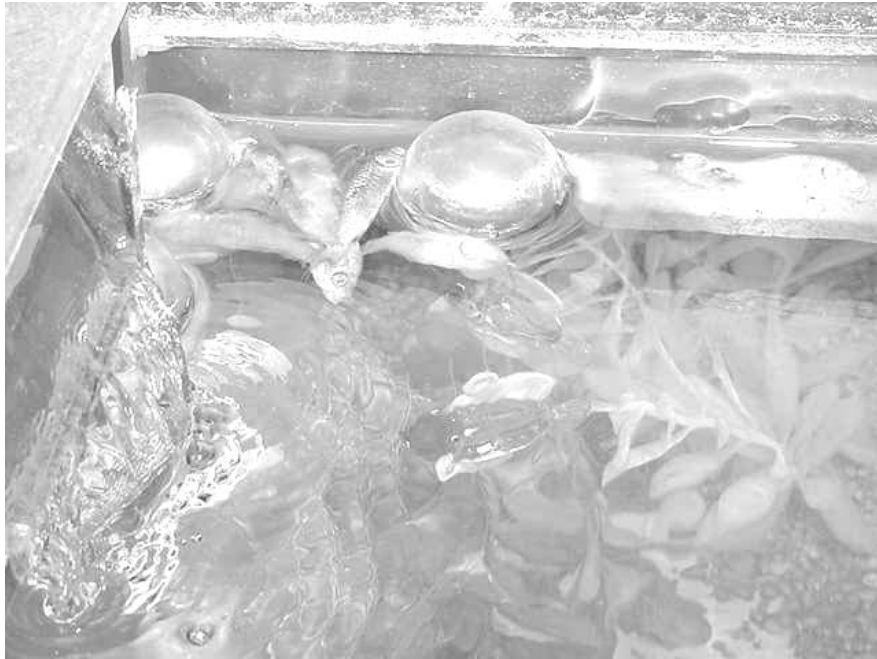
Picture 13

Decaying Fish Bodies Floating In Classroom 111 Aquarium

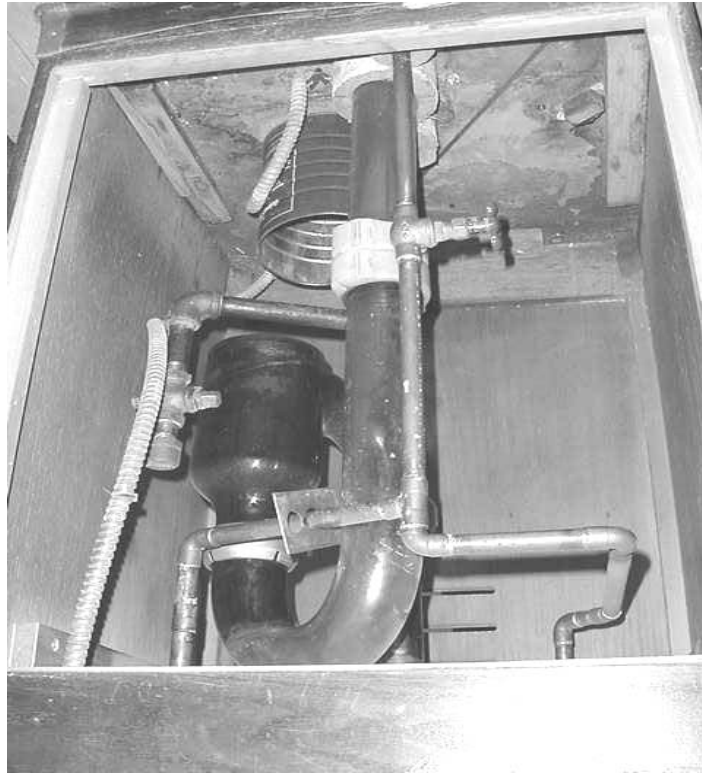
Picture 14

A number of current/former science classrooms are equipped with freestanding sinks, which appear to be used infrequently. Building occupants in this area reported odors from the drains. Sinks are equipped with drain traps that form a water seal to prevent the backup of sewer odors. Without water, the airtight seal on the trap can be breached; resulting in sewer gas backing up the drains and entering occupied areas. Sewer gas can create nuisance odors and be irritating to certain individuals. BEHA staff noted unpleasant odors from the sink in 315; the trap was inspected and was found clogged with debris preventing drainage, allowing water in the drain to stagnate.

Drain Clogged with Debris in Science Classroom 315

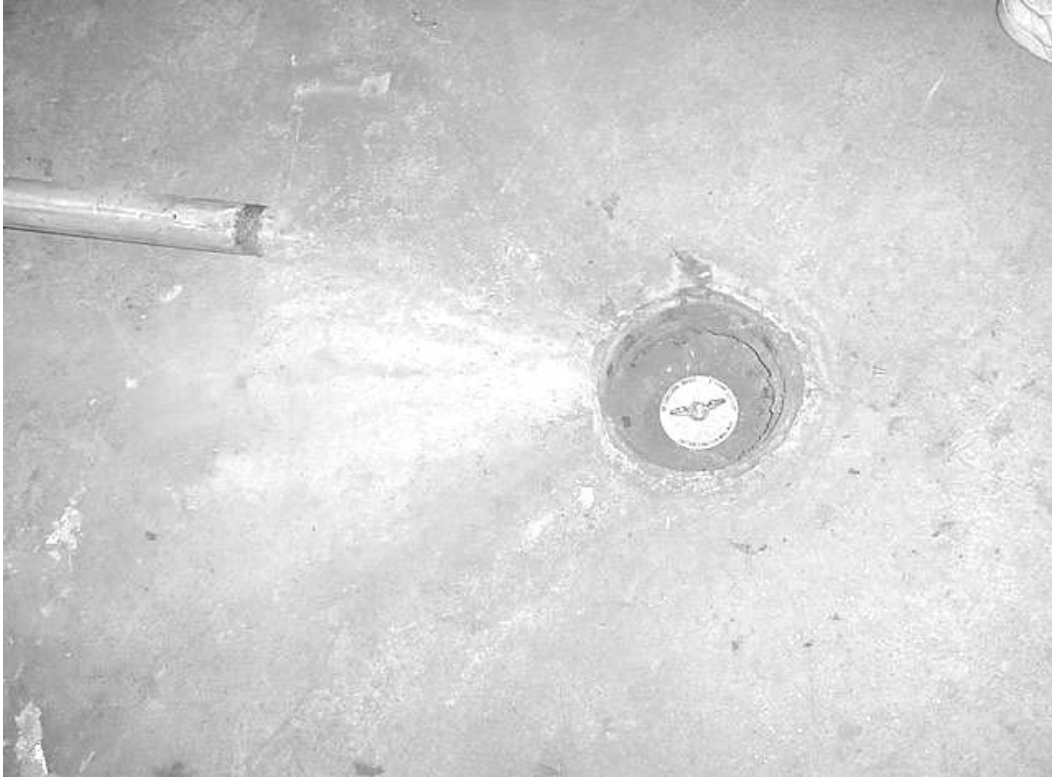
Picture 15

penetrating into occupied spaces. When water enters a drain, the trap fills and forms a watertight seal. Without a periodic input of water (e.g., every other day), traps can dry, breaking the watertight seal. Without a watertight seal, odors or other material can travel up the drain and enter the occupied space. Both the floor drains and condensation drains have traps. During the heating season, AHUs do not produce condensation, which dries the traps. This AHU was found to be drawing air into the unit through the condensation drains. With each condensation drain acting as a vacuum, odors from the floor drain without a water-sealed trap can draw into the AHUs and be distributed to occupied areas in the building. This drain was capped to prevent future occurrence (see Picture 15).

Condensation Drain Pipe From AHU and Sealed Drain in Mechanical Room

2. Seal the condensation drains for AHUs during the heating season. Please note that these drains must be unsealed during the air-conditioning season in order to drain condensation. Failure to remove condensation drain seals can result in water back up into AHUs and the potential for mold growth.

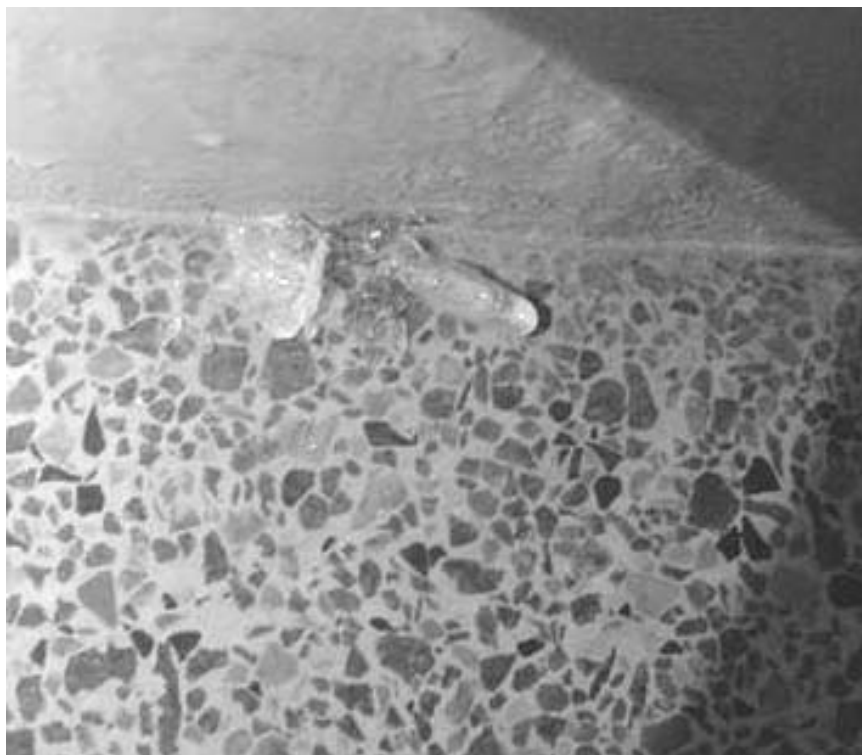
Picture 16

School officials also reported that a rotten egg odor was reported in the general vicinity of the library shortly after the detection of sewer gas odors. BEHA staff inspected the library stairwell and found the remnants of a glass ampoule on the first floor landing against the wall (see Picture 16). Previous BEHA assessments have identified similar materials (MDPH, 2001) as “Stinkbomb Ammonium Sulfide”. Ammonium sulfide solution is both a respiratory irritant and flammable material.

Broken Glass from Ammonium Sulfide Ampoule

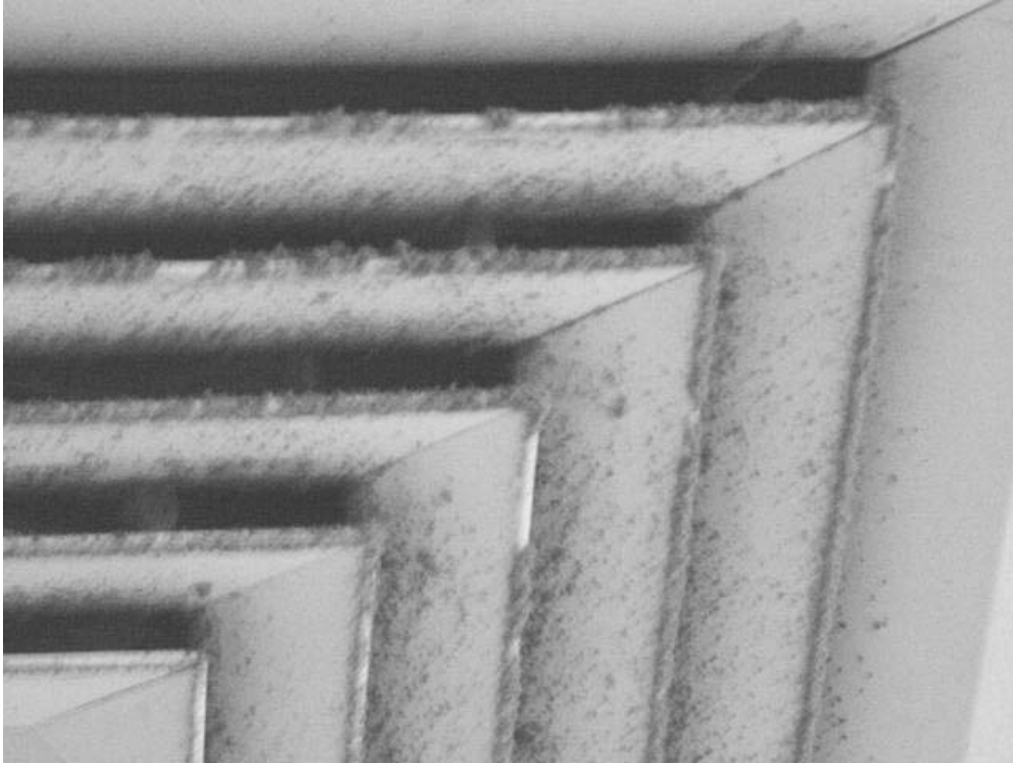
Picture 17

Close-Up of Accumulated Dust Build-Up on Exhaust Vent

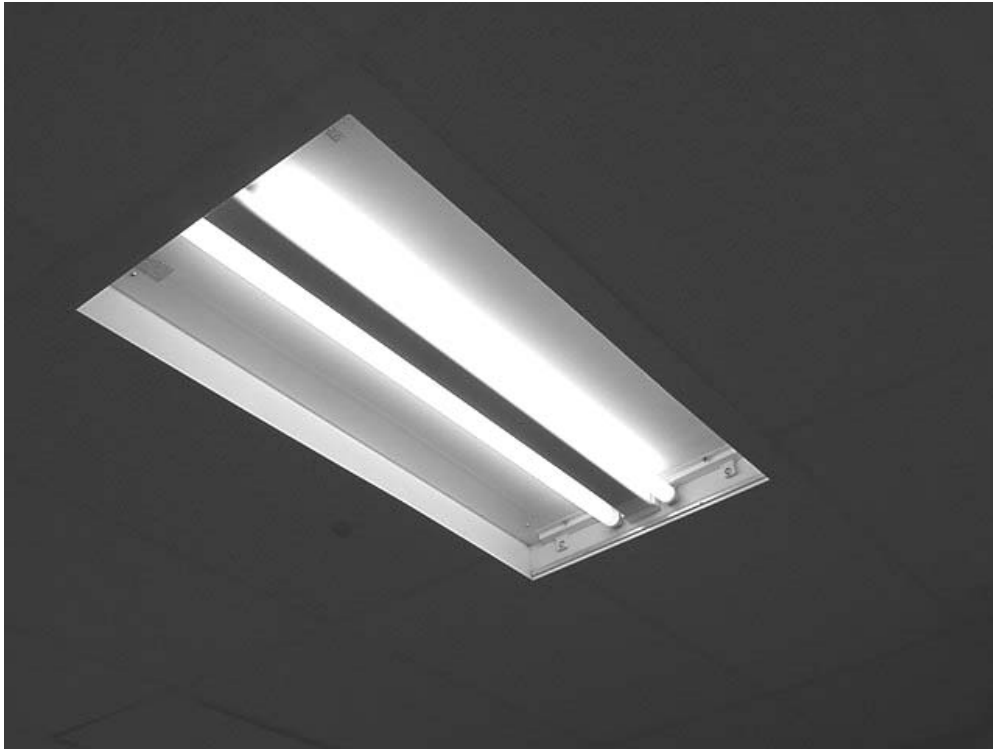
Picture 18

Although lighting was not reported as an issue in the building, improper lighting can have an effect on the comfort of individuals in a building leading to complaints such as headaches, nausea, visual fatigue and eye strain. Insufficient lighting can also effect the ability to concentrate and reduce work performance (NSC, 1996). Lighting fixtures throughout the building were at half capacity (see Picture 18). It was reported by school officials that ballasts in each lighting unit were removed as an energy conservation measure during the late 1970's early 1980's.

Typical Lighting Fixture in Classroom Note Only One of Two Fluorescent Bulbs Installed
